TenCate Polyfelt PGM & PGM-G

Investigation of a road rehabilitated with TenCate Polyfelt PGM 14 after a service period of seven years

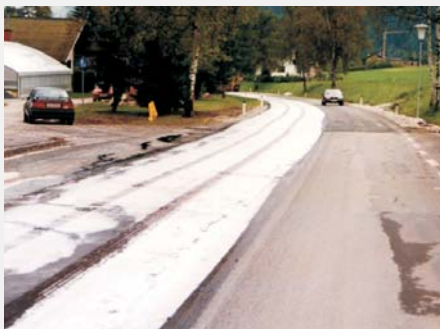
The B 98 during the maintenance works (1993): PGM 14 installed on one lane.

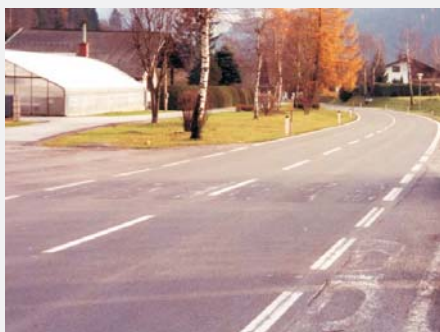
The same section after seven years in service (2000).

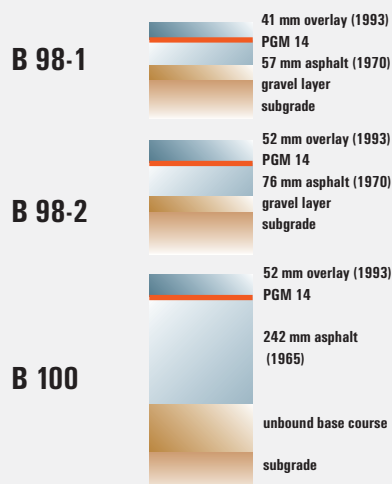
The structures of the investigated road sections are illustrated in the diagram below. On the B 98, an old mastix asphalt constructed in 1970 was the basis for therehabilitation works. This type of structure is not longer in use, due to its lack of frost resistance. The structure of the B 100 constructed in 1965 corresponds to the regulations of Type 1 auf the Austrian standard RVS 3.63.

Cross sections of the investigated road sections, with the avg. thicknesses of the layers measured at the drilling cores.

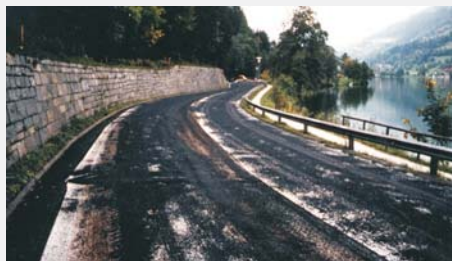
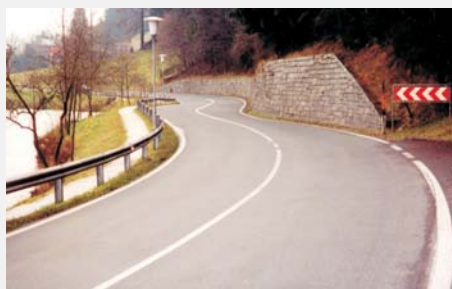
Top: The B 98 during maintenance works (1993): Bituminous chippings were sprayed onto the PGM 14 in order to allow traffic temporarily.
Below: The same section after seven years in service (2000)

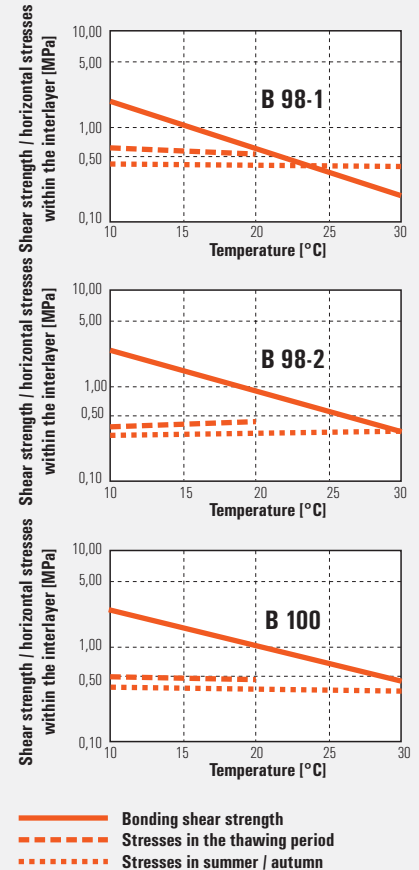
The calculated horizontal stresses within the interlayer are compared to the bonding shear strength values in the diagram on the right. Just in section B 98-1, at higher temperatures in summer the horizontal stresses exceed the bonding shear strength, which is another clear evidence for the insufficient design.

Bonding shear strength and horizontal stresses within the interlayer.
